# Remediated sites and brownfields Success stories in Europe

*A report of the European  
Information and  
Observation Network's  
National Reference Centres  
for Soil (Eionet NRC Soil)*

How to cite: JRC, 2015. Remediated sites and brownfields. Success stories in Europe; EUR 27530 EN; doi 102788/406096

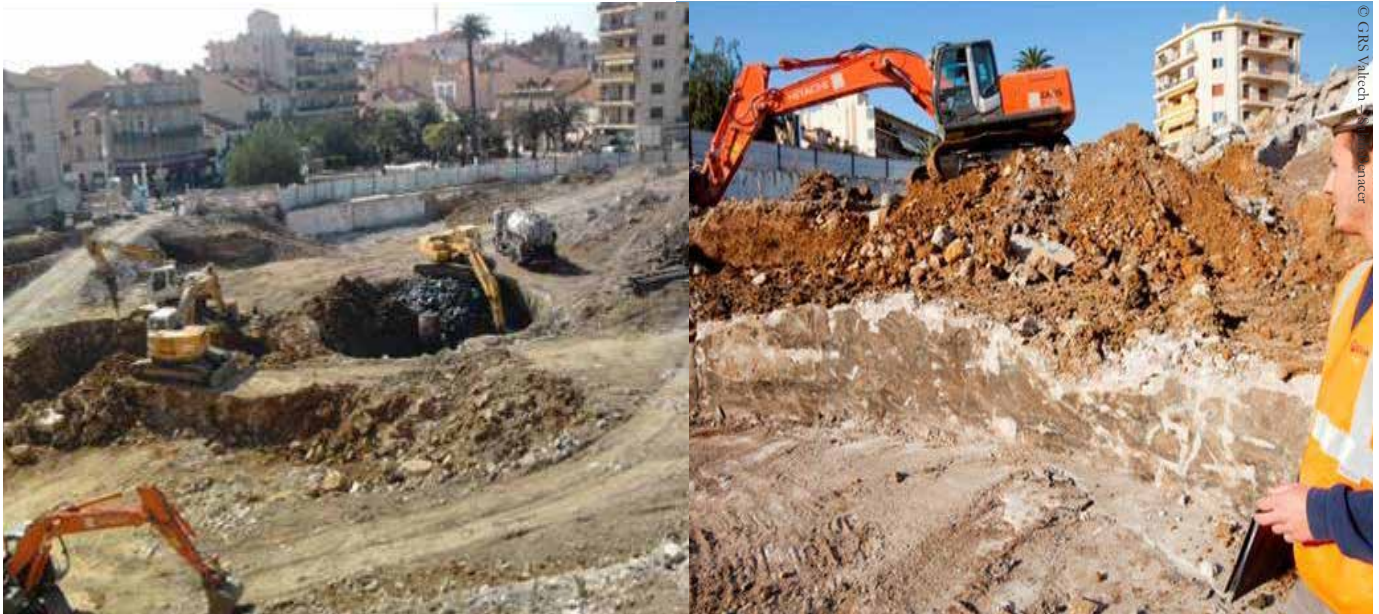
France, Cannes. Remediation works at former GDF-Suez gas plant

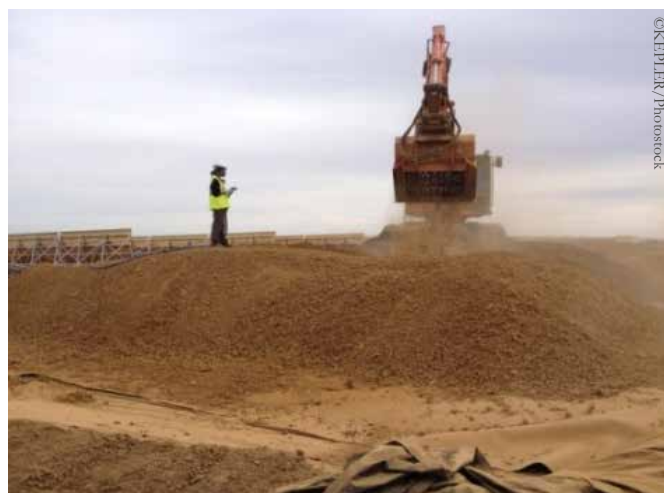
Soil turning and applying of the solution of nutrients and microorganisms.

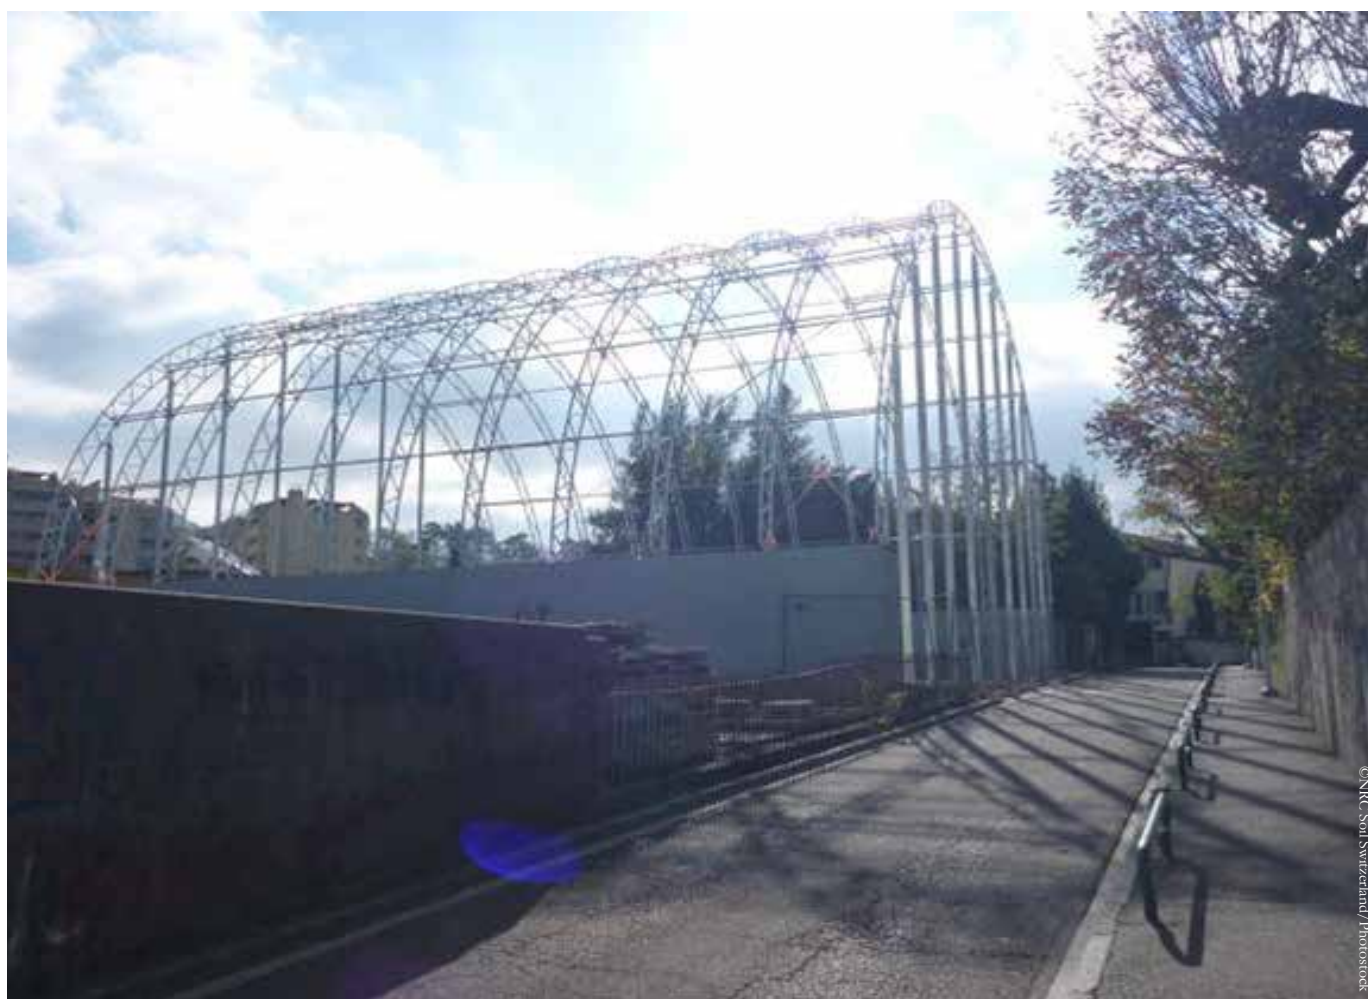
Protective cover under construction

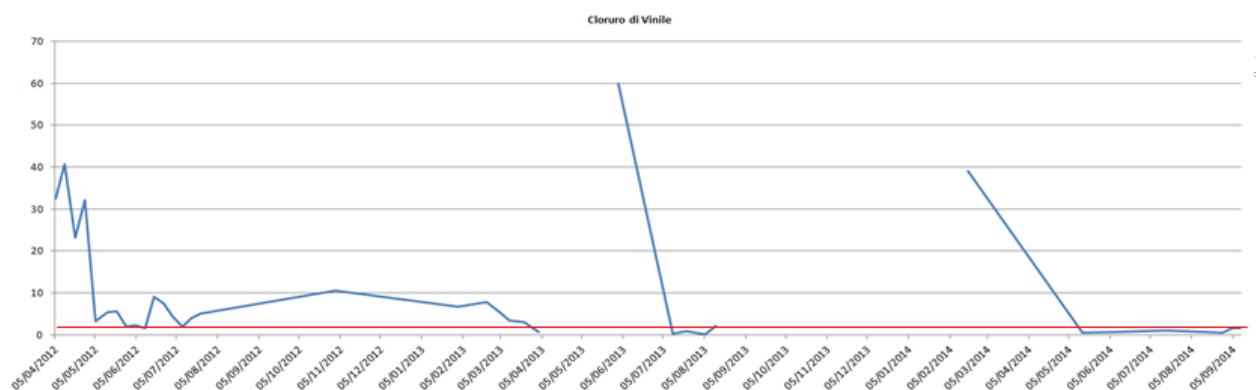
Concentration of Vinyl Chloride in groundwater (in blue), the red line represents the Screening Value (SV).

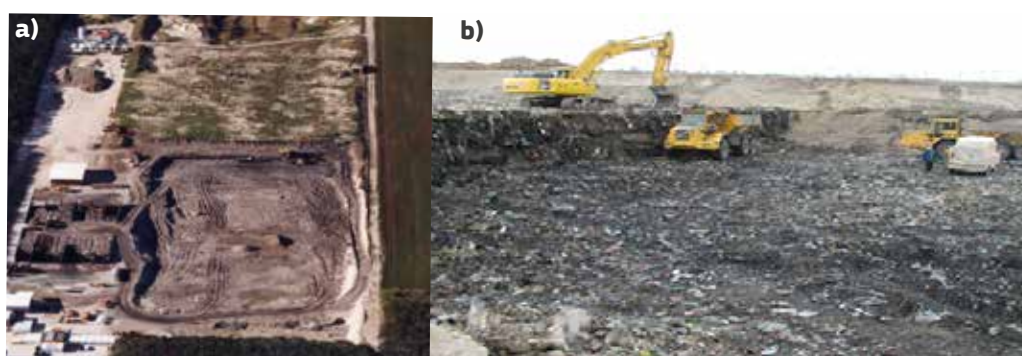
From left to right: a) Aerial view of the site at the beginning of the clear-up operations  
b) Excavation of municipal waste with a skeleton-excavator

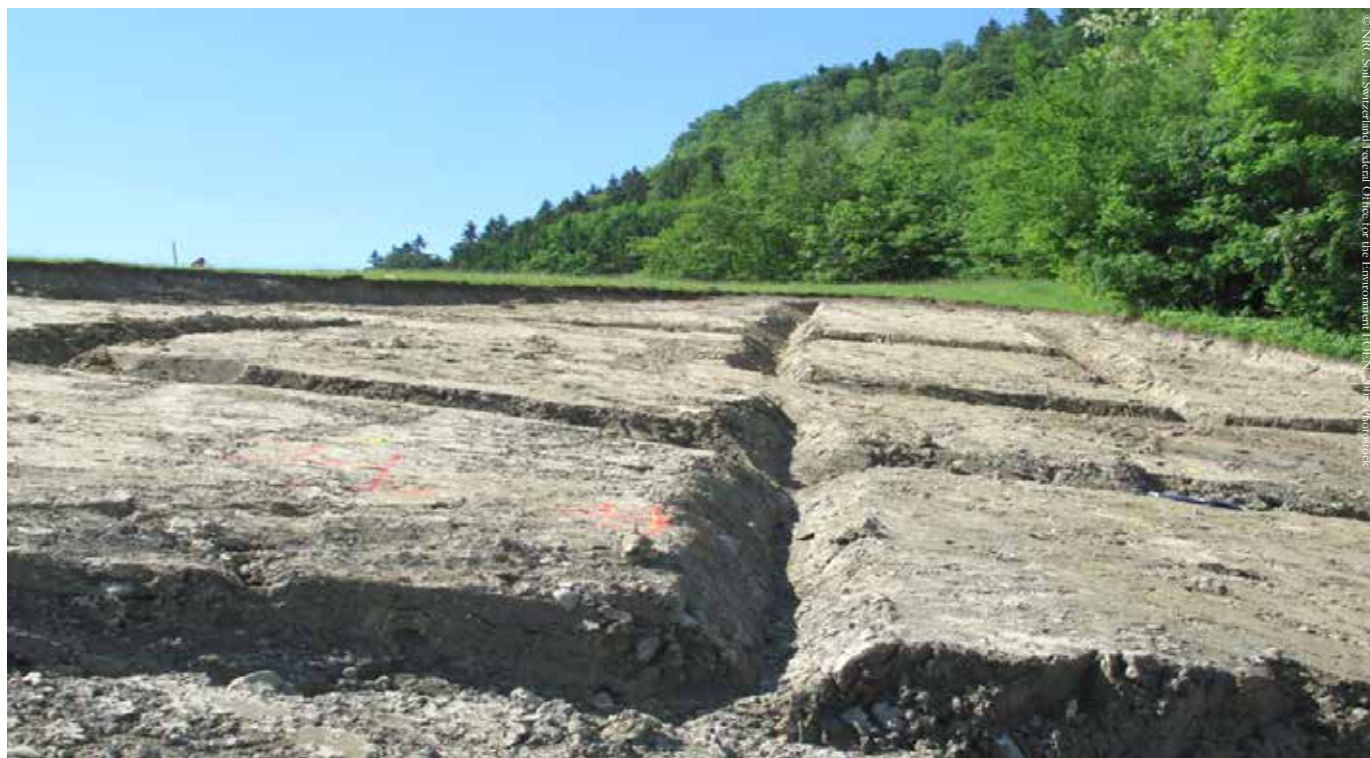
Construction of surface drainage features for controlled management of the rainwater

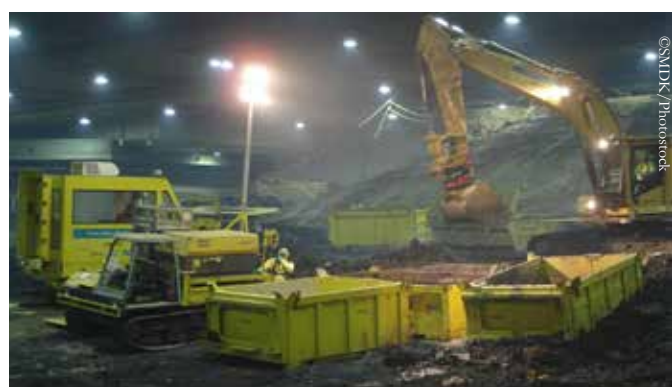
Typical configuration of the landfill dismantling activities during the first dismantling stage (2007-2009).

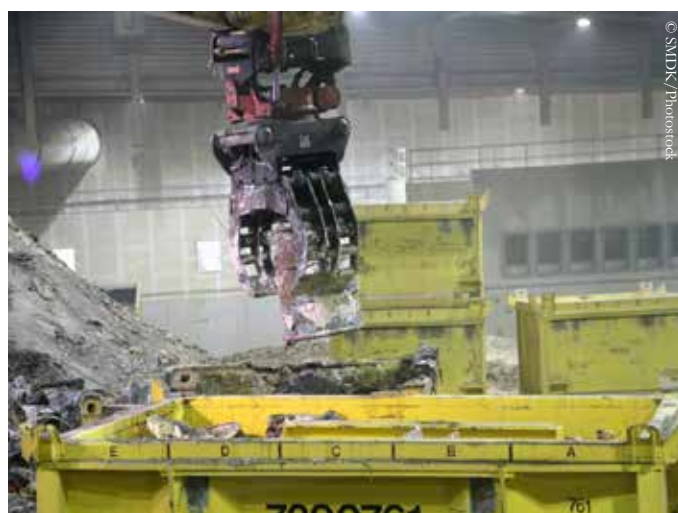
Retrieving a waste drum with the excavator.

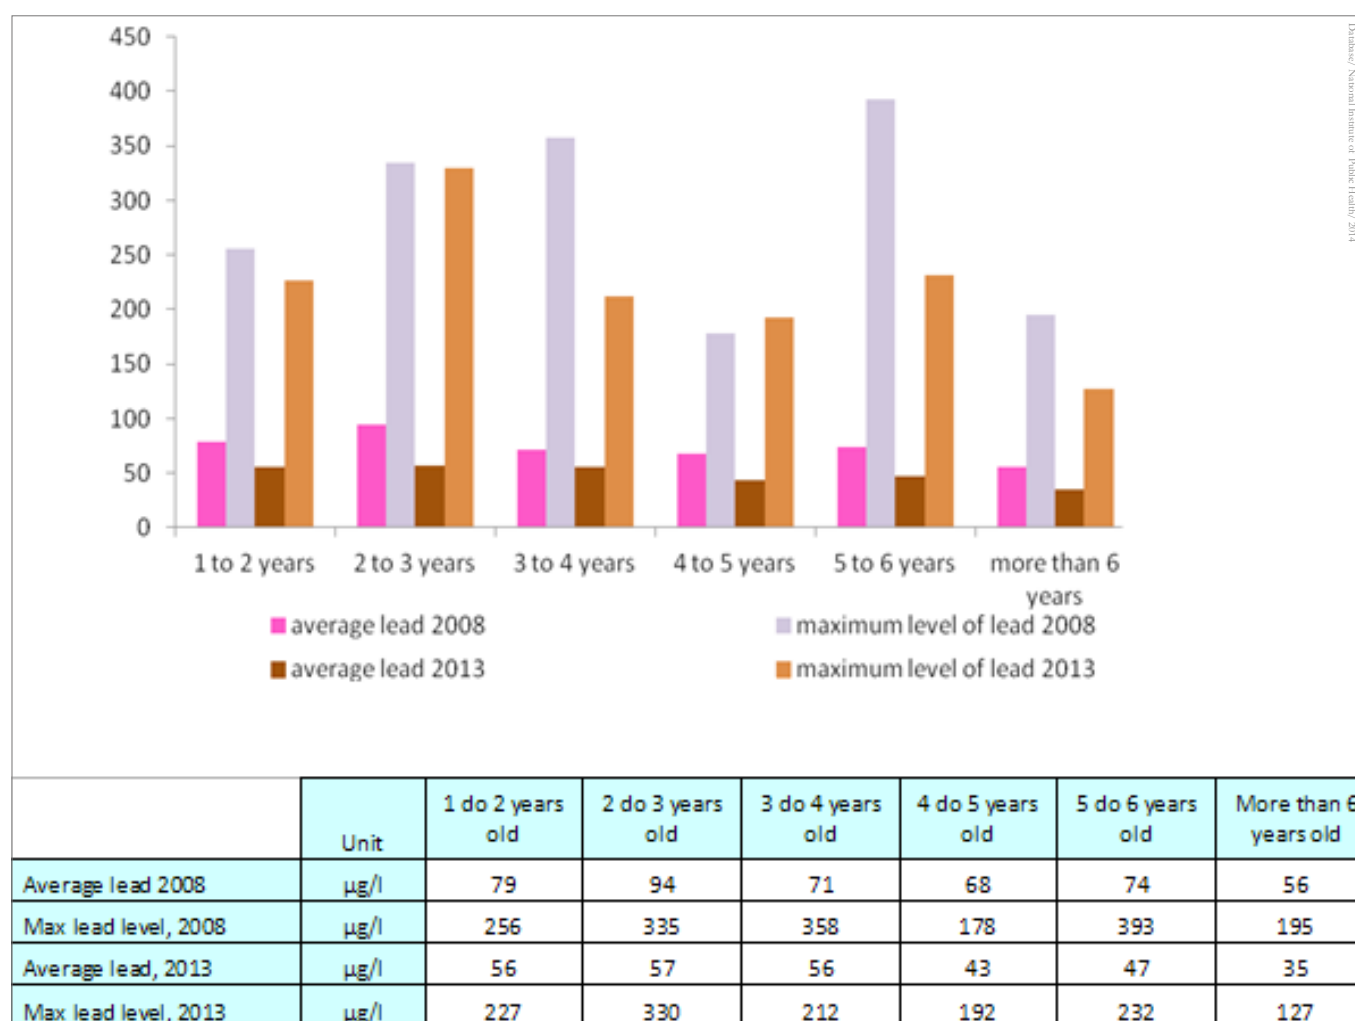
Average levels of lead in blood of children from the Upper Meža Valley in 2013 according to age groups (target value is 100µg/l blood)<sup>5</sup>.

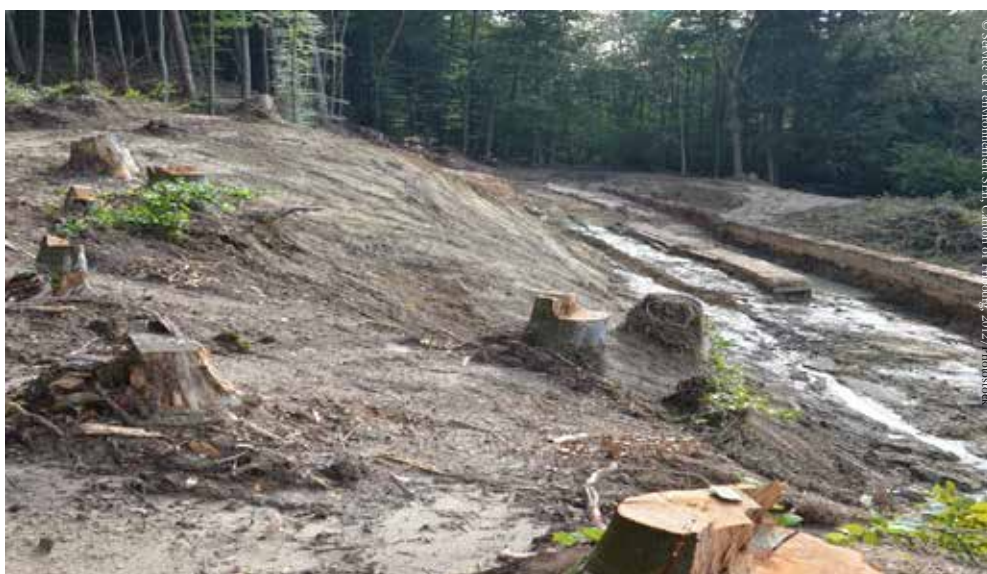
Former indicator and indicator trench with decontaminated earthen backstop.

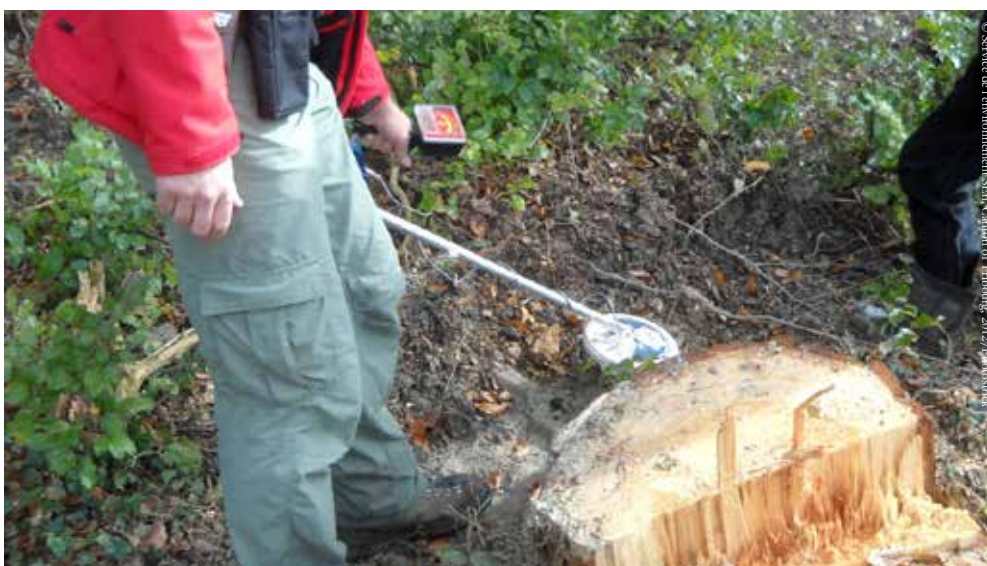
Individual small hotspots are identified with the metal searching device.
